## **Material qualification in saline, copper containing geothermal water**

### **ABSTRACT**

During circulation tests at the geothermal research facility in Groß Schönebeck (Germany), massive copper precipitation has been observed downhole clogging the production well. Occurring mechanisms and measures to prevent copper precipitation or scaling needed to be investigated.

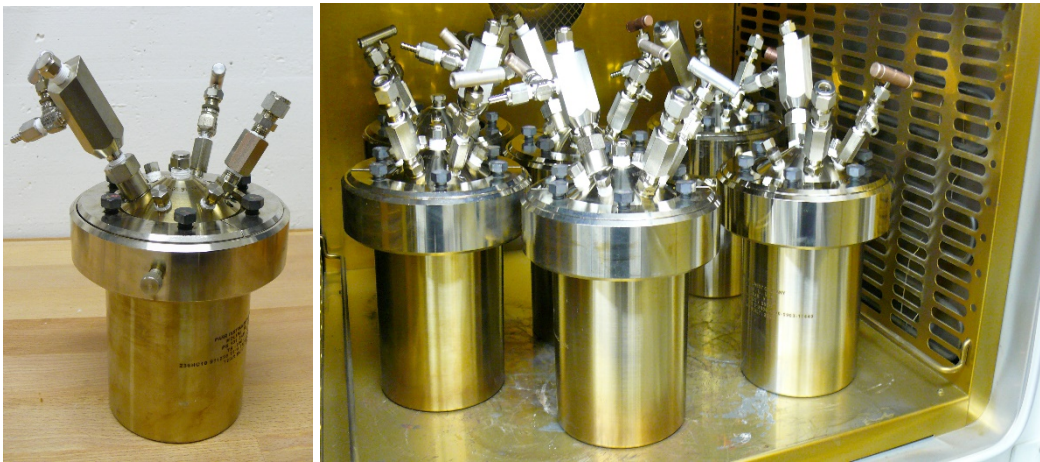
Exposure tests were carried out according to DIN 50905/4<sup>9</sup> with gravimetric determination of time dependent corrosion within a heating cabinet to provide uniform temperature distribution. Tests were carried out in 1-Liter-autoclaves (figure 1) having a glass-inlay. Three specimens were completely immersed into the solution. Exposure time was up to one month at 150 °C.

**Figure 1: Vessels for exposure tests**

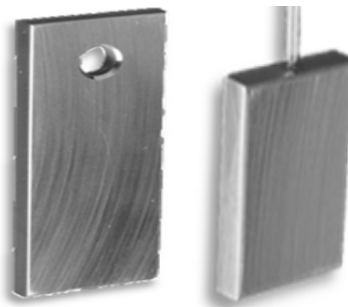
Test specimens were machined from a plate by water jetting. Before testing, surfaces were ground by 120 SiC-paper, degreased by acetone and dried. The size for test specimens (l x w x t) was 20 x 7 x 6 mm. A set of 3 specimens was used. Each exposure test specimen had a 5 mm hole for fixation using a polytetrafluoroethylene (PTFE)-cord (figure 2, left).

**Figure 2: Specimen design for exposure (left) and electrochemical (right) tests**

Investigations were carried out using a typical 3-electrode configuration within a 1-L-autoclave equipped with a PTFE-encapsulated saturated Ag/AgCl reference electrode (-220 mV<sub>SHE</sub>) and a Ti-oxide covered titanium mesh as a counter electrode. The temperature in the autoclave was adjusted by an external hotplate and constantly monitored by a thermocouple. The autoclave was additionally located in a sand bath to avoid electrical interferences between heater and measurement device (figure 3). The specimen size for electrochemical tests resulted in 8 cm<sup>2</sup> surface (figure 2, right). All specimens were ground to grit 320 to have comparable surface conditions.

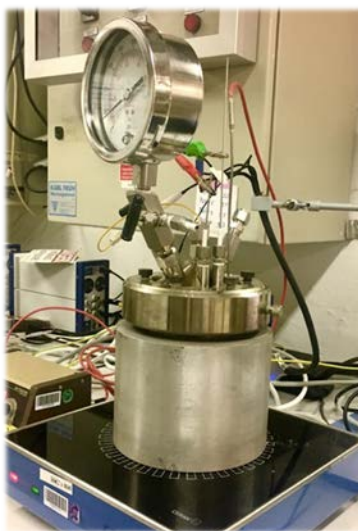
Figure 3: Test setup for electrochemical tests

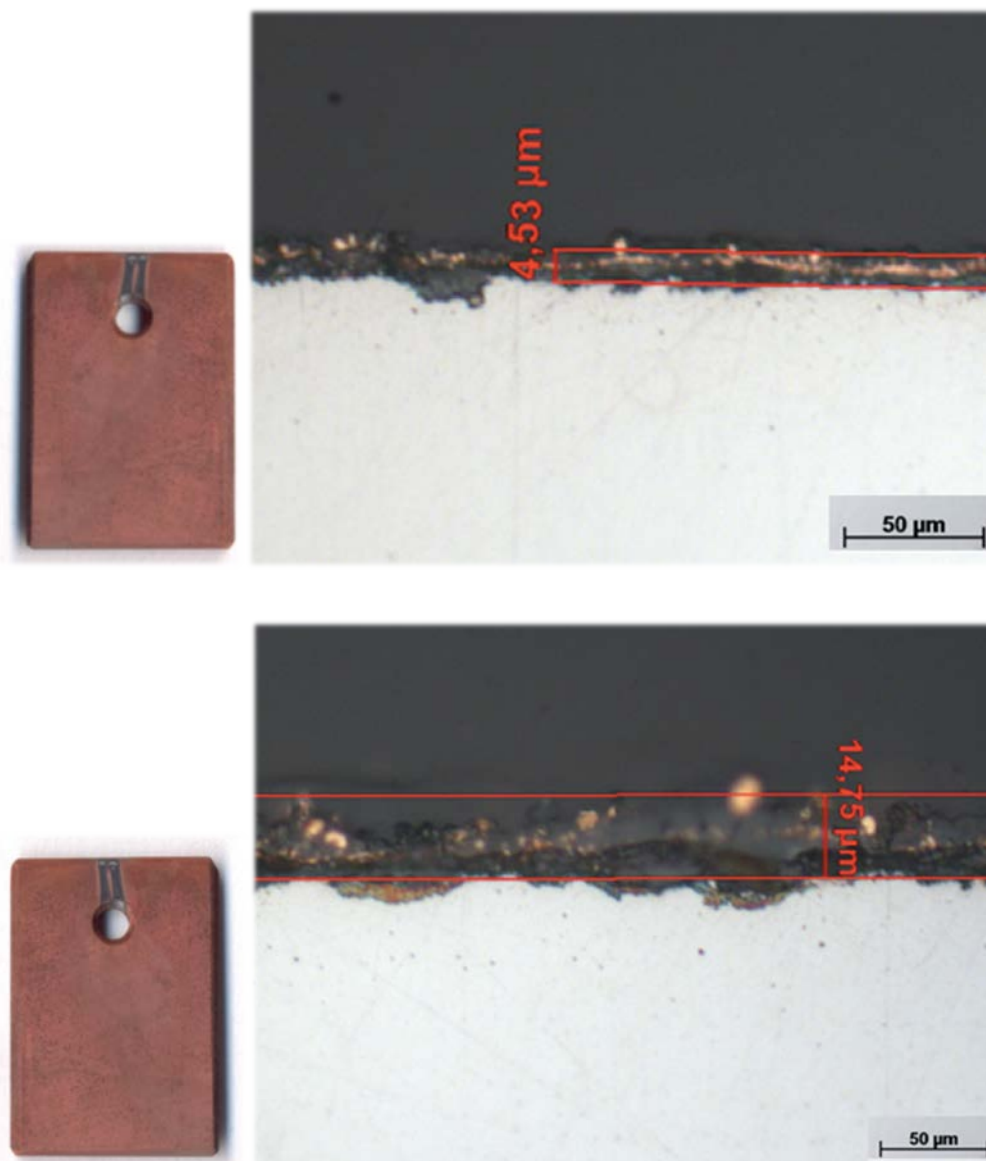
Already after 24 hours a uniformly distributed copper layer was found on carbon steel. Appearance of specimen surface and thickness of deposited Cu-layer are shown in figure 4. After one day a thickness of 4.53  $\mu\text{m}$  was determined growing to 14.75  $\mu\text{m}$  after one week.

Additionally, the copper concentration of the medium was measured. At the beginning it was 63 mg/L, after 24 hours 9.5 mg/L and after one week 5.4 mg/L. So continuous deposition could be observed. Also, a reddish precipitation (presumably Cu and iron hydroxide) was detected.

**Figure 4: Copper deposition on carbon steel after 1 day (top) and 1 week (bottom)**

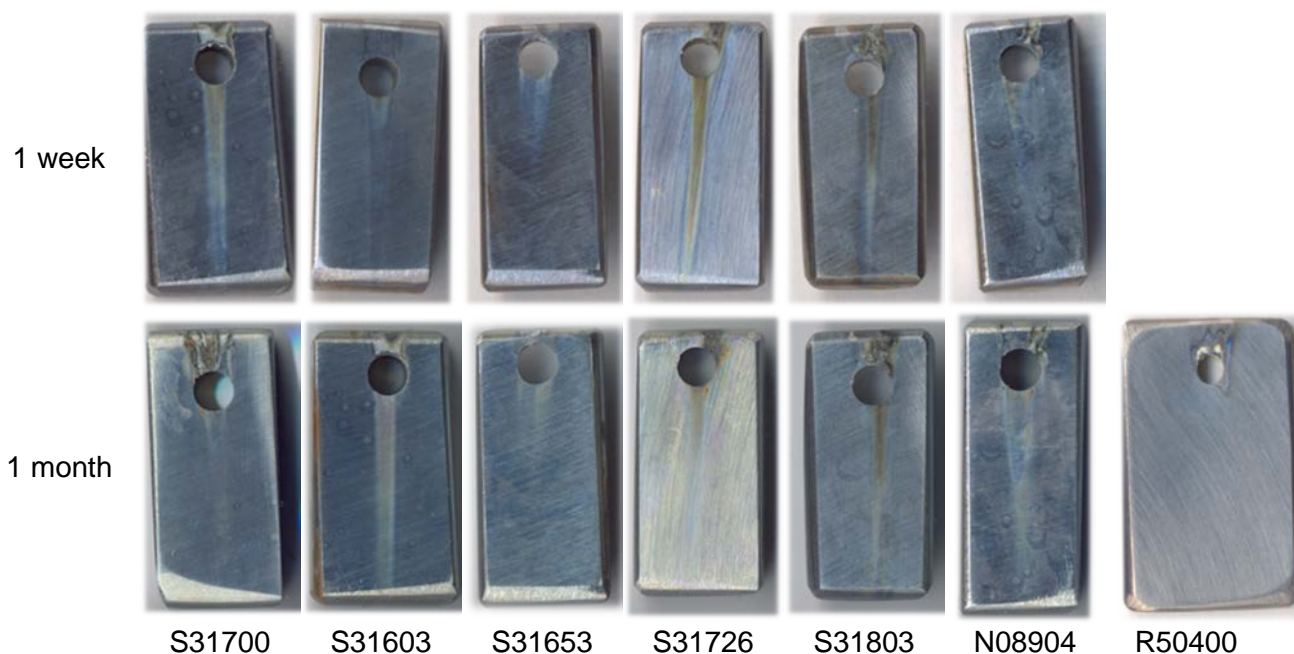
Appearance of the high alloyed and Ti-alloy test specimens after certain times of exposure in Cu-containing artificial geothermal water is shown in figure 5.

In addition to no Cu-deposition, no signs of general or pitting corrosion could be detected. Within the area of fixation some markups pointed to a potential susceptibility to crevice corrosion, as discussed already in previous publications <sup>1-3</sup>.

**Figure 5: Surface appearance after one week and one month exposure in Cu-containing geothermal water**

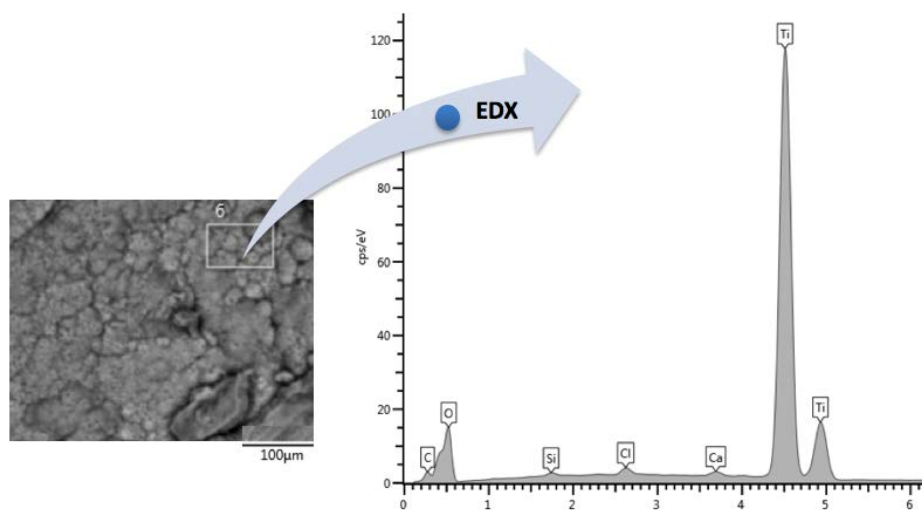
**Figure 6: EDX spectrum on R50400-specimen after one month exposure**

EDX-analysis of Ti-alloy surface after 1 month exposure showed, that depositions found on the surface consist of salt-components of the geothermal water (figure 6). No Cu-species could be detected.

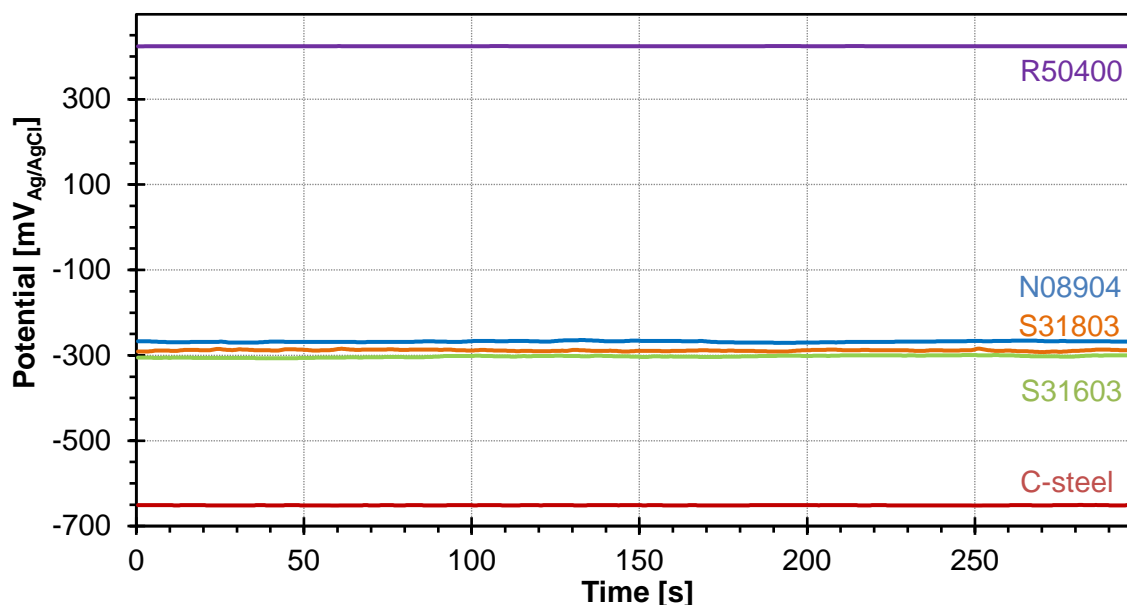
All specimens exhibited quite stable open circuit potentials within one week of exposure. Selected recorded potentials are shown in figure 7. A survey of measured values is given in table 3. As expected,

OCP of C-steel was the lowest, followed by the high-alloyed materials. Ti-alloy showed the most positive OCP.

Figure 7: Open circuit potentials in artificial Cu-containing geothermal water

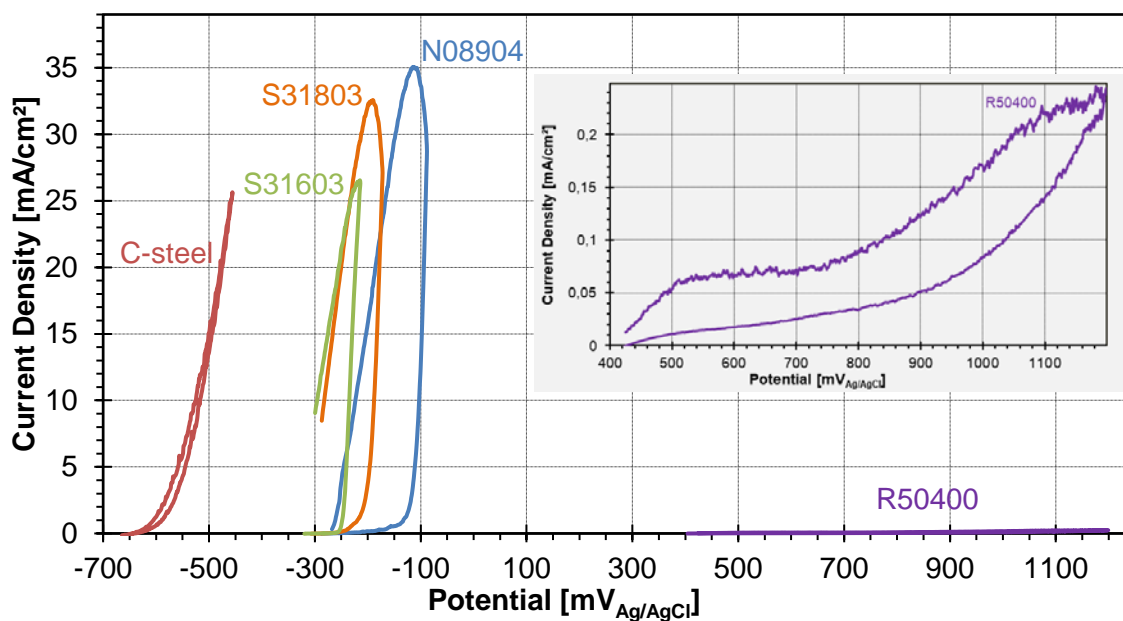
Current density potential curves measured at different materials are shown in figure 8. A significant difference was found, following the OCP ranking.

Figure 8: Current density potential curves in Cu-containing artificial geothermal water

Polarizing the specimens caused Cu deposition on C-steel. Hysteresis (pointing to localized corrosion and bad repassivation behavior) could be found for S31603, S31803 and N08904. No pitting was found on R50400. Surface appearance is shown in figure 9.

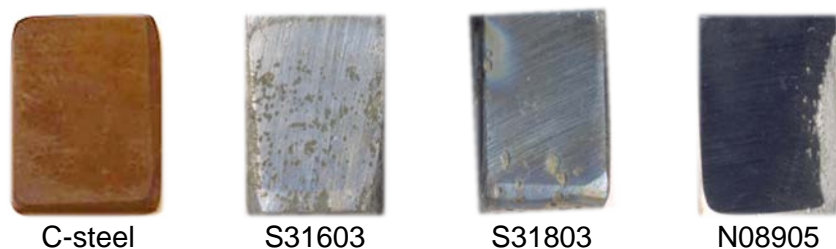
**Figure 9: Surface appearance after potentiodynamic polarization**
